2.4.1 Timber and timber

2.4.2 Timber and metal

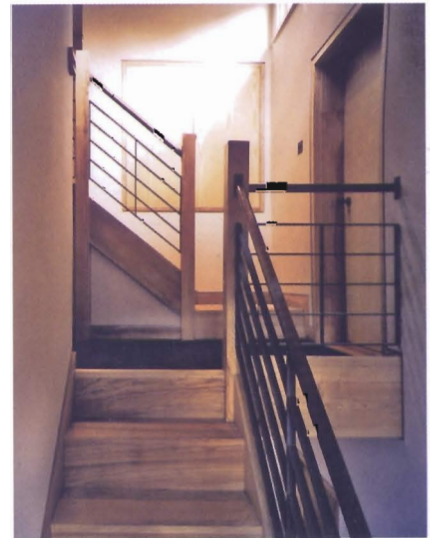
Figure 2.8 The ash staircase replaces one that had rotted

What then do you restore, and what do you keep? When Richard Griffiths Architects was working on *Sutton House* in Hackney, East London, for the National Trust, one of the joys of the building was that it dated from so many different periods. 'What was interesting about Sutton House was that it had been altered at almost every period in its history,' Griffiths said. So the temptation was to keep all the additions. But in fact, he says, 'the repair philosophy was different in every room'. With two existing languages of construction – oak and iron from the 16th Century, and painted softwood and brass from the 18th Century – Griffiths selected a third language for his new interventions. These, which included a new draught lobby, and a new staircase (*Figure 2.8*) in place of one that had rotted altogether, were in ash and bronze.

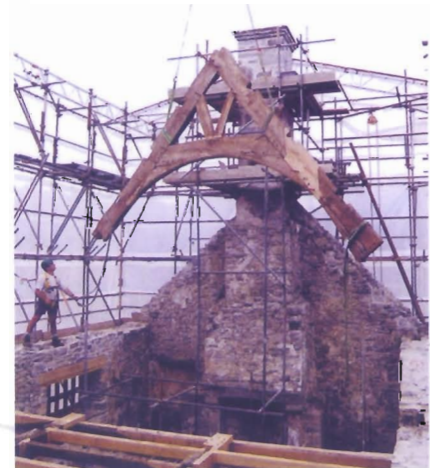
Figure 2.9 A restored truss is lowered into position at *Dobelydr*

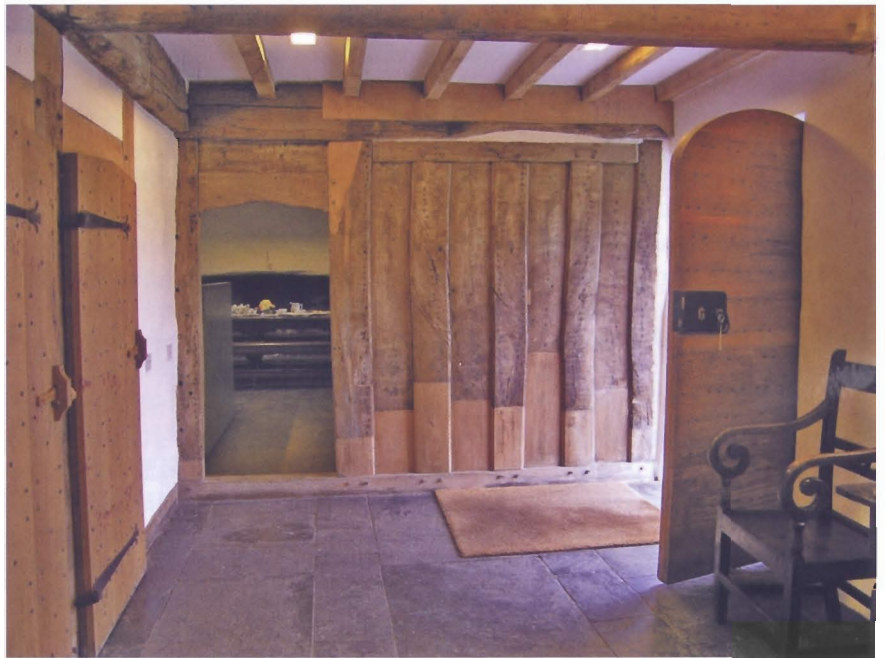
Figure 2.10 Patched heavy timber panelling a lobby at Dobelydr
Photo: Carpenter Oak & Woodland

Few projects look to maintain as much of the original fabric as this, but the degree of conservation that is required varies. When *Dobelydr* in St Asaph, North Wales, was restored for the Landmark Trust, there was a determination to retain as much of the historic fabric as possible. The 16th Century house is often considered as the cradle of the Welsh language, since it was there that Henry Salesbury wrote the first Welsh grammar in 1593. A timber-framed stone building (*Figure 2.9*), it was in a very poor state, with many of the timbers collapsed inside, where Carpenter Oak and Woodland, the specialist contractor, found them and repaired them, ready for reinstatement. Chris Masters, one of the team that worked on the project, described it as 'a very extreme conservation job'. He was involved chiefly in restoring the floor beams and joists, and in some cases, where hardly any original fabric remained, would take a half-inch thick piece of timber and fix it to an entirely new beam. The finished building, an obvious and rather beautiful patchwork of old and new, with heavy timber panelling (*Figure 2.10*) as well as structure, is now owned by the Landmark Trust.

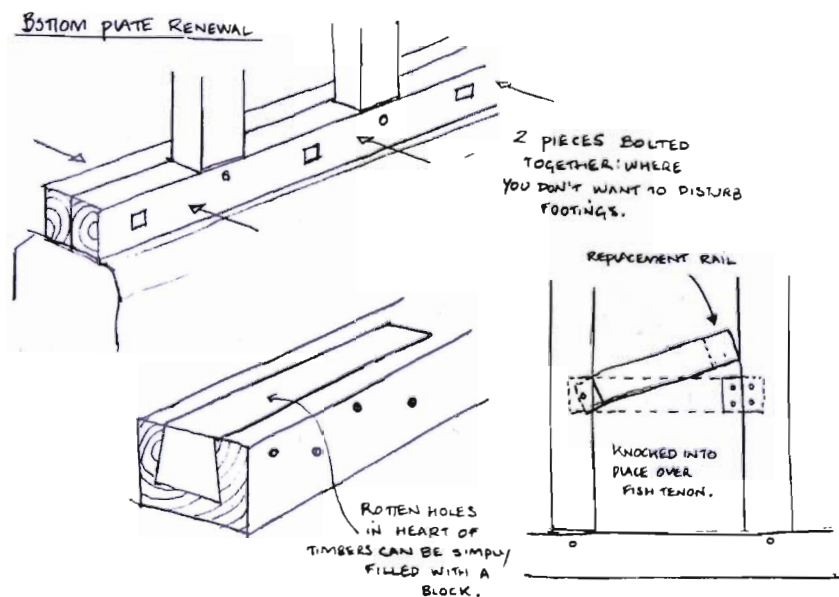
Figure 2.14 A carpenter's ideas for renewing baseplates and replacing rails
 Sketch: Carpenter Oak & Woodland

There are many tried and tested ways of repairing timber with new timber elements, often fixed with timber pegs as well. There are scarf joints, where you cut out the offending piece of timber and fix in a new one. There are different descriptions such as halved scarfs and splayed scarfs, depending on the exact form, and an expert carpenter will decide which is most appropriate in which instance. The underlying principle is that you create a long bearing surface between the old timber and the new timber, so that there is plenty of space for fixings and for the two to bond. *Figure 2.14* is an example of carpenter's sketches

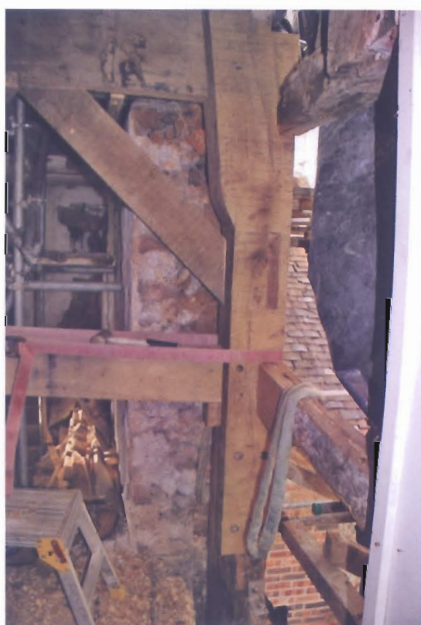
Figure 2.15 New for old
 Photo: Carpenter Oak & Woodland

It may seem as if replacing damaged timber with more timber (*Figure 2.15*) is the most straightforward and 'honest' of solutions. However, even when it is technically appropriate to do so, it may not be considered the most appropriate solution in conservation terms. This is because, depending on the nature of the building and the building's history, what conservationists consider to be most important may be the actual fabric of the building – and repairs such as scarf joints actually involve removing quite a lot of the fabric. It may be necessary to remove any damaged timber, or at least to bypass it, for structural reasons. Scarf joints only work if good timber is bonded to other good timber. In order to create the surfaces for a scarf joint, it will therefore be necessary to cut away quite a lot of the sound timber. In conservation terms this may not be considered acceptable and so, against intuition, the best conservation solution may be to strap the joint or in some other way use metal to hold the elements together.

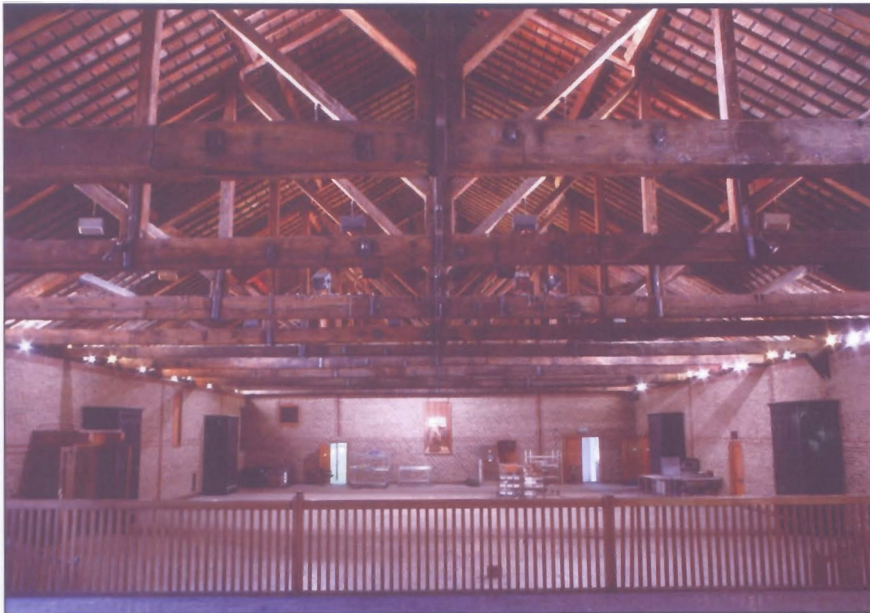
Figure 2.16 Concealed stainless steel rods strengthen these trusses at the Porter Tun Room

Some repairs with metal are more sophisticated. They may be done to correct original design errors, or they may be made to buildings that already used some metal elements. At *St Mark's*, Silvertown, when Julian Harrap Architects was rebuilding the roof, a structural analysis showed that there was an inherent weakness in the roof, and pieces of metal were put in to strengthen it (*Figure 2.16*).
